Sometimes It's the

By Steven R. Southard,
Naval Sea Systems Command Deep Submergence Branch

Simple Things . . .

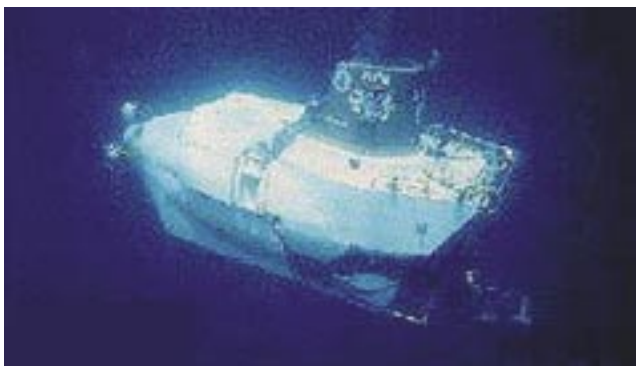
With things back to normal and after being overhauled following its recovery, *Alvin* continues to serve the Navy and is shown operating in its environment: the ocean depths.
